Manhole Inspection Summary

Manhole # S29UU1017MH

Location Address: **200 WYNDHURST AVE**

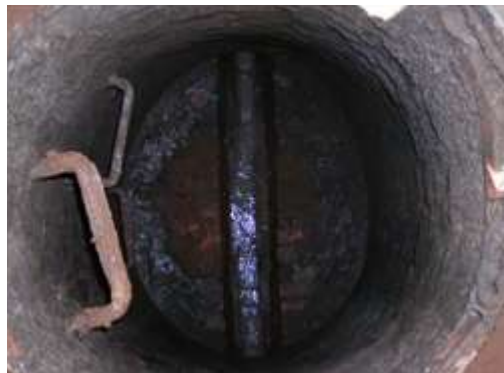
Top View

☒ **Corroded**

☒ **Evidence Of Surcharge**

Corroded steps. Evidence of surcharge - Bench debris.

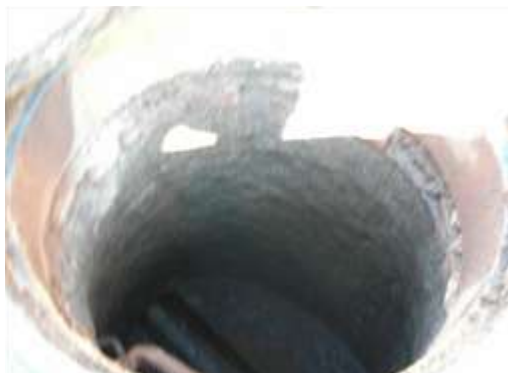
Defect

☒ **Leaks**

Condition: ☐ Sound ☐ Cracked ☐ Root Intrusion ☐ Loose Brick ☒ **Deteriorated**

Infiltration: ☐ None ☒ **Joint** ☐ Cracks ☒ **Mortar** ☐ Roots ☒ **Wall**

Frame leaks. Adjustment deterioration, loose brick and infiltration - other side.

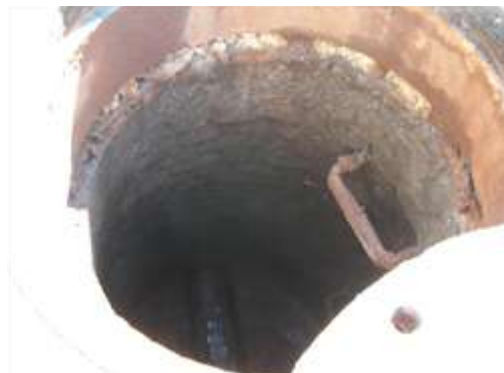
Defect

Frame leaks. Adjustment deterioration, loose brick and infiltration.
